Figure 1 Silverlink Bridge - Gilesgate

This enquiry was triggered by concern over the effects of bottle-mining on the steep banks of Pelaw Beck. Some of the adjacent land (since developed for housing) had for long years been occupied by a soft drinks manufacturer, some of the old bottles buried as rubbish being now deemed as valuable. The excavations have been undermining mature trees and so threatening damage to the 1938 Silverlink steel footbridge (Span 190 ft). This was of concern to the Friends of Pelaw Wood, a voluntary group charged with woods management on behalf of Durham County Council. Neither the Police nor the Council have

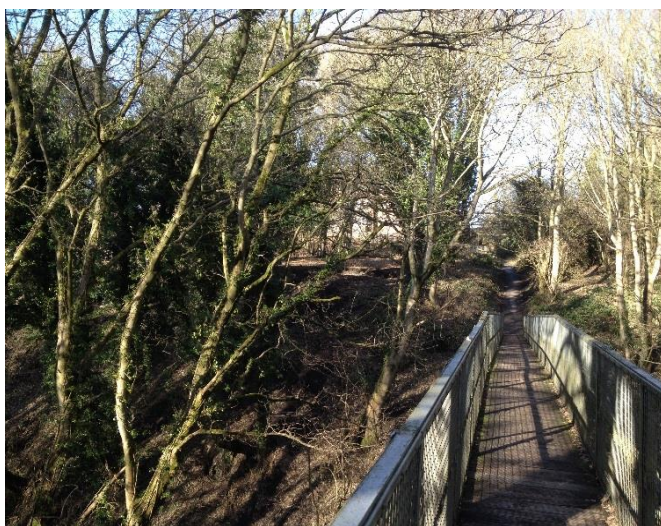
Figure 3 On bridge looking northwards - trees overhanging

In view of the inherent danger to the bridge structure from falling trees, it is imperative that appropriate land and woodland management be put in place for the newly delineated 0.4 acre site of unregistered brownfield land. It would seem that this can only be done effectively by the land ownership being vested in Durham County Council using the legislation noted above. Site inspection and the photographs show the heavily wooded nature of the terrain, with numbers of mature trees rooted in steeply sloping ground (areas of which have been subject to historic tipping) close to the bridge. The prevailing SW wind and illicit bottle-mining, which currently cannot be prevented, considerably add to the risk factor.

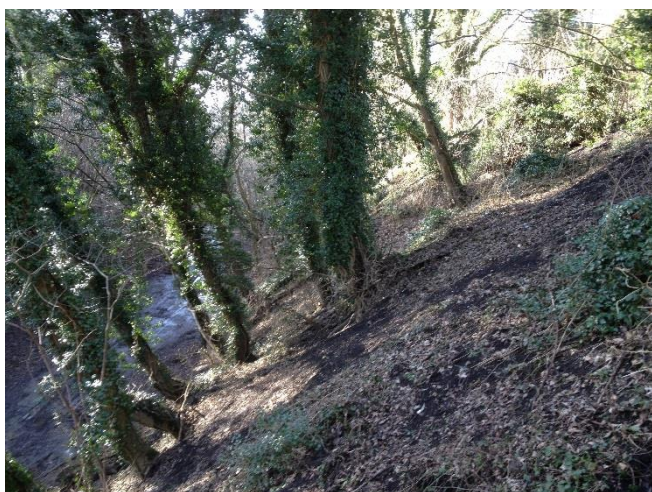
**The boundaries of the unregistered wooded land** on the steep northern bank of Pelaw Beck (which triggered the need for this enquiry) can therefore now be determined with reasonable precision. Southern boundary is the Beck, northern boundary is determined by the parcel of land owned by Miller Homes on the south side of their St Giles Court development, eastern boundary is determined by the parcel of land owned by Durham County Council (at bridge abutment) and western boundary by that of St Giles' Western Churchyard. **(Area of this parcel of unregistered land is c. 0.4 acre)**

Figure 4 The steeply sloping unregistered land (c. 0.4 acre)
